# SERVICE BULLETIN

**LAWN MOWER #105**  
**APRIL 2015**

## HRX217K5VYA UNINTENTIONAL ROTO-STOP® DISENGAGEMENT

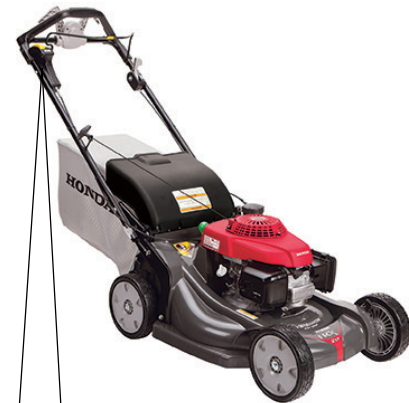
In certain instances, the Roto-Stop® may unintentionally disengage (stopping blade rotation) while mowing.

MODEL	SERIAL NUMBER RANGE
HRX217K5VYA	MAGA-2370001 ~ 2405366

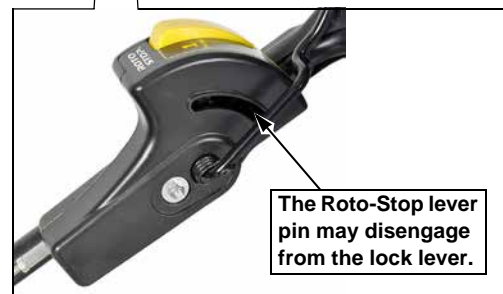
The Roto-Stop lever may not fit between the handlebars properly, resulting in side-to-side free play. This allows the lever pin to move to the left and disengage from the lock lever inside the Roto-Stop mechanism.

Follow the repair procedure below to increase the width of the lever on any affected unit with the described symptom.
